for the VDU card with the CMOS Junior

The VDU card published in Elektor number 101, September 1983, sometimes lets noise appear on the screen, such as when a program is being listed. This fault can easily be remedied by means of a few gates in the VDU card that are unused in the Junior Computer/VDU card combination.

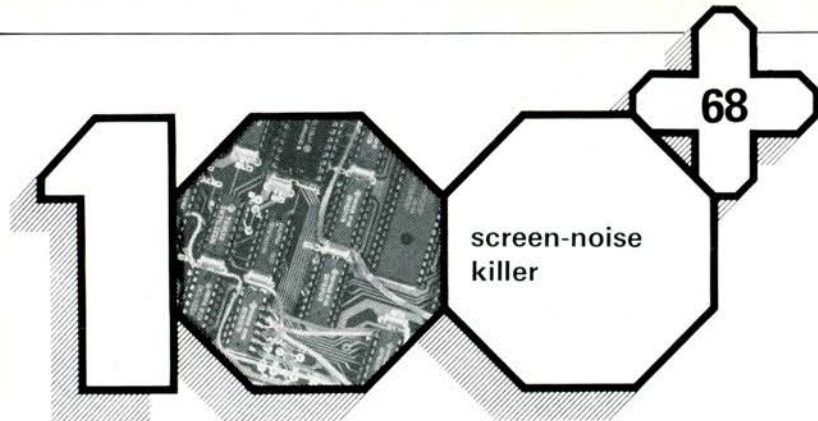
The trick of the circuit consists of stopping the processor when it attempts to write to the video RAM during the display enable time. Only the 65C02 can be stopped during writing so this circuit operates exclusively with Junior Computers equipped with the CMOS Processor. This procedure causes a slight delay

they are no longer in the IC sockets:  
 IC2 pins 7, 9, 11 and 13  
 IC4 pins 1, 8, 9 and 10  
 IC7 pins 1, 8, 9, 10, 11, 12, and 13  
 IC8 pin 8  
 IC17 pin 1.

These pins are then connected together as indicated by the heavy lines in the circuit diagram. Pin 1 of IC17 simply remains open, while pin 2 of IC7 is already connected to ground. Note that pin 1 of IC14 and pin 12 of IC17 must remain pushed into their respective sockets even after wires are soldered onto them. Another possible 'extra' for the VDU card is to show a frame on the monitor within which all the video data is displayed. All this requires is a single 1 k resistor connected between pin 5 of IC17 and the collector of T1.
