MOS TECHNOLOGY, INC.

The attached Errata Sheet #3 should be used to eliminate additional errors discovered in the documentation for your KIM-1 System. Please mark your KIM-1 User Manual to reflect these changes.

KIM-1
Errata Sheet #3

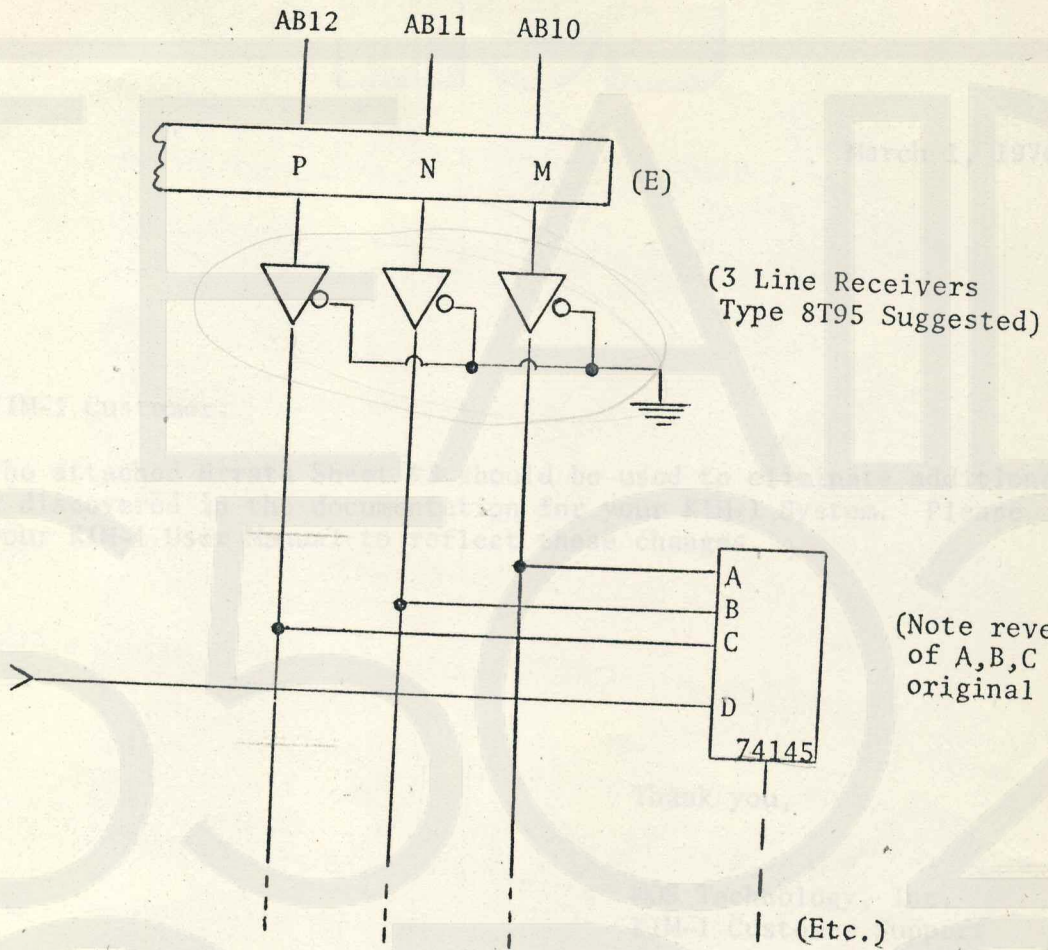
- Page C-2 - in the fourth line from the top, change to Pin A-P (not A-B).
- Page 74 - the schematic of Fig. 6.2 should be changed to show a more commonly available non-inverting line receiver. Also, the connections to the decoders (74145) should be corrected as shown in the diagram on the following page:
